**ASTM E 330 and ASTM E 1886/1996  
PERFORMANCE TEST REPORT**

**ORIOLOM CORPORATION**

**PRODUCT TYPE: Quick Shutter Clamping System**

**Report No.: 78828.01-401-44**  
**Test Dates: 12/27/07**  
**Through: 02/15/08**  
**Report Date: 02/15/08**  
**Expiration Date: 02/15/12**

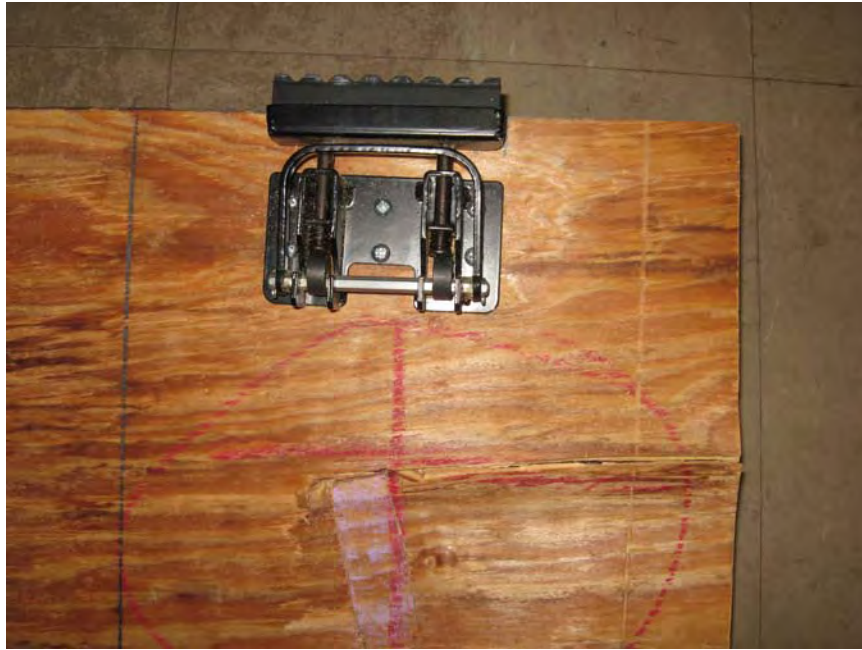
**Photo No. 1**  
**Specimen # 3**  
**Upper Right Corner Impact**

**Impact Area:** Upper right corner

**Observations:** Missile hit impact area, left 1/2" depression in panel

**Maximum Dynamic Deflection:** 24.6 mm (0.97")

**Residual Deflection:** 23.9 mm (0.94")

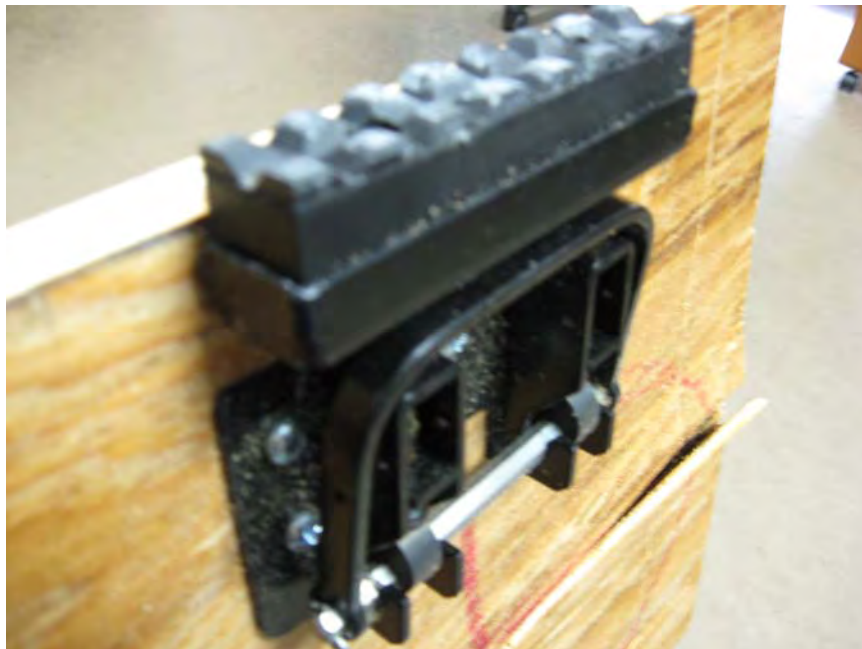
**Photo No. 2**  
**Specimen # 3**  
**Quick Shutter Clamp**

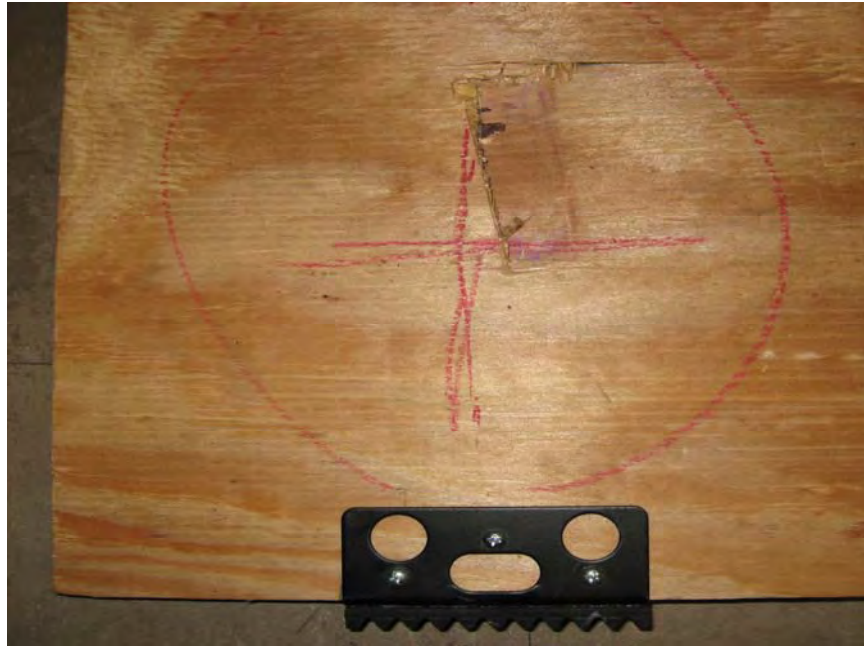
**Photo No. 3**  
**Specimen # 2**  
**Lower Left Corner Impact**

**Impact Area:** Lower left corner

**Observations:** Missile hit impact area, left 3/8" depression in panel

**Maximum Dynamic Deflection:** 21.1 mm (0.83")

**Residual Deflection:** 16.3 mm (0.64")

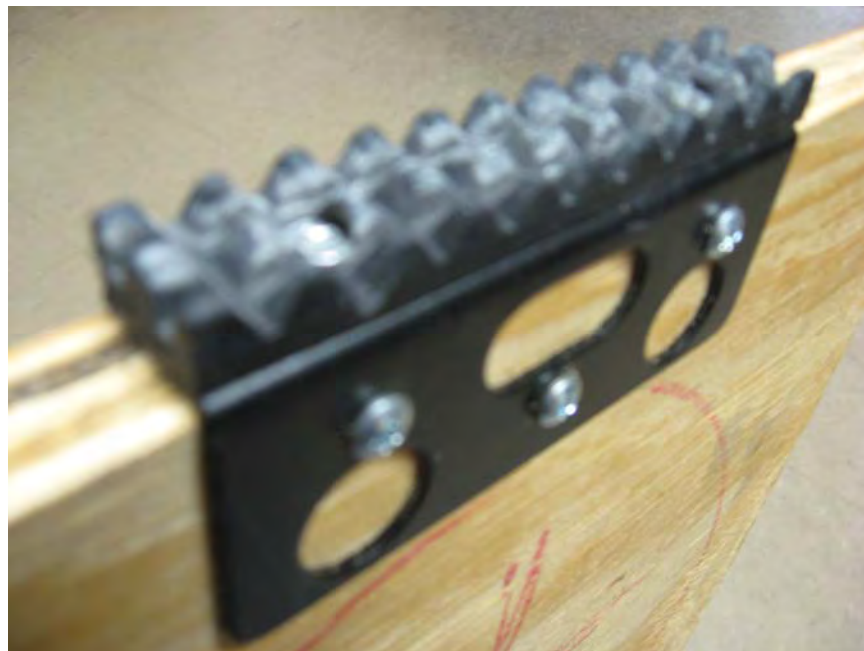
**Photo No. 4**  
**Specimen # 2**  
**Quick Shutter Bumper**
